Manhole Inspection Summary

Manhole # S41MM_004MH

Insp Date: **3/27/07 7:51 AM**

Location Address: **1230 20TH ST**

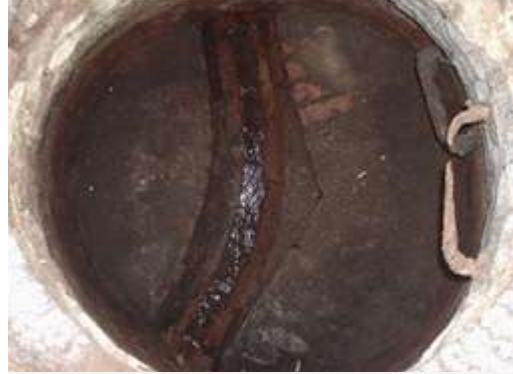
Top View

Corroded and missing steps. Evidence of surcharge - Bench debris.

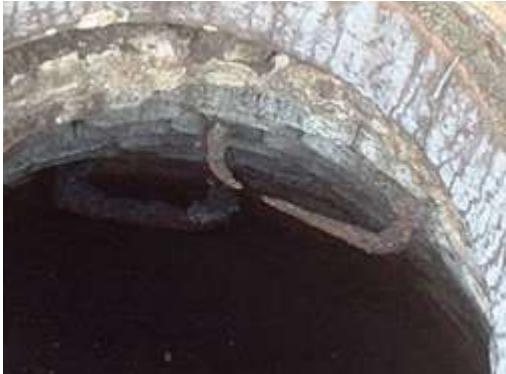
Defect

Adjustment deterioration and infiltration. Corroded and missing steps. Barrel infiltration.

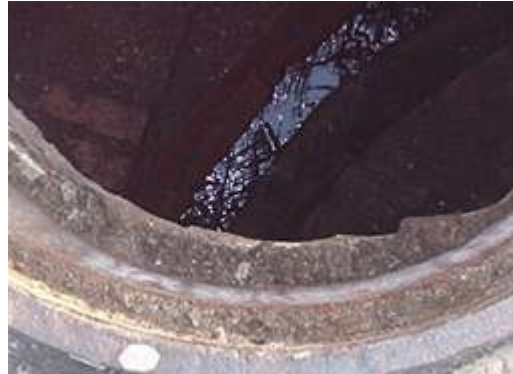
Defect

Frame offset.

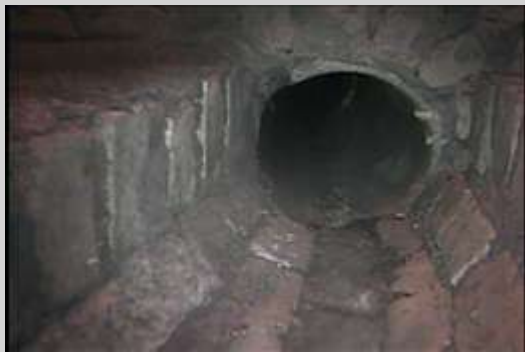
Pipe Out @ 12 O'Clock

Pipe Material: **Clay** ☐ Pipe Lined

Invert Depth: **5.74** (ft.) Flow Characteristics: **Slow**

Infiltration: **None** Pipe Seal Cond: **Unknown**

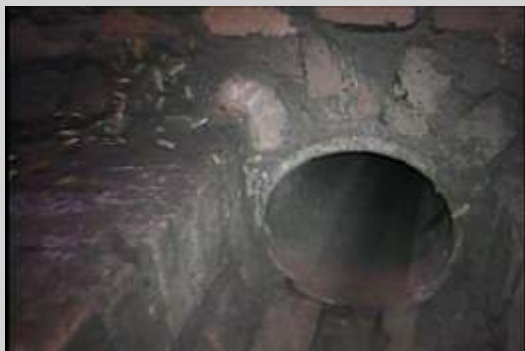
Pipe In @ 8 O'Clock

Pipe Material: **Clay** ☐ Pipe Lined

Invert Depth: **5.59** (ft.) Flow Characteristics: **Slow**

Infiltration: **None** Pipe Seal Cond: **Unknown**
